WT  
**NASA Contractor Report 165794**

(NASA-CR-165794) INVESTIGATION OF SEVERE  
LIGHTNING STRIKE INCIDENTS TO TWO USAF  
F-106A AIRCRAFT (NASA) 19 p HC A02/MF A01  
CSCI 01C

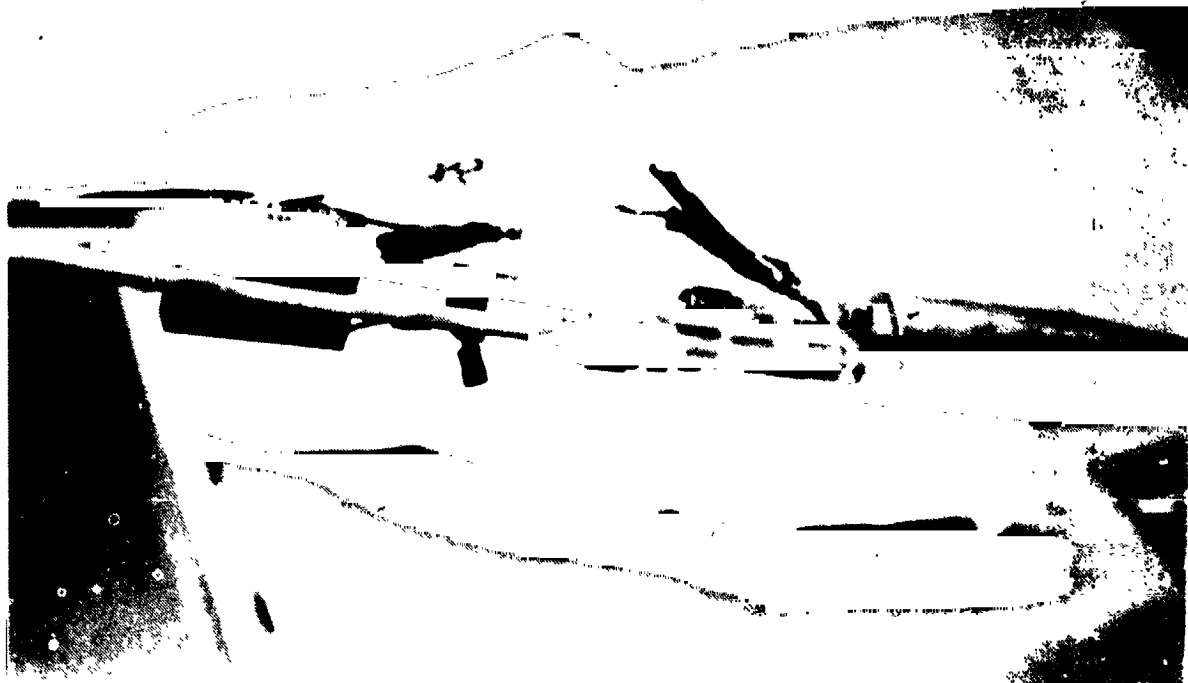
Figure 1 - Pitot Heater Ground Wire Burned Away from  
Splice in Boom of Aircraft A.  
"Hot" wire was disconnected later).

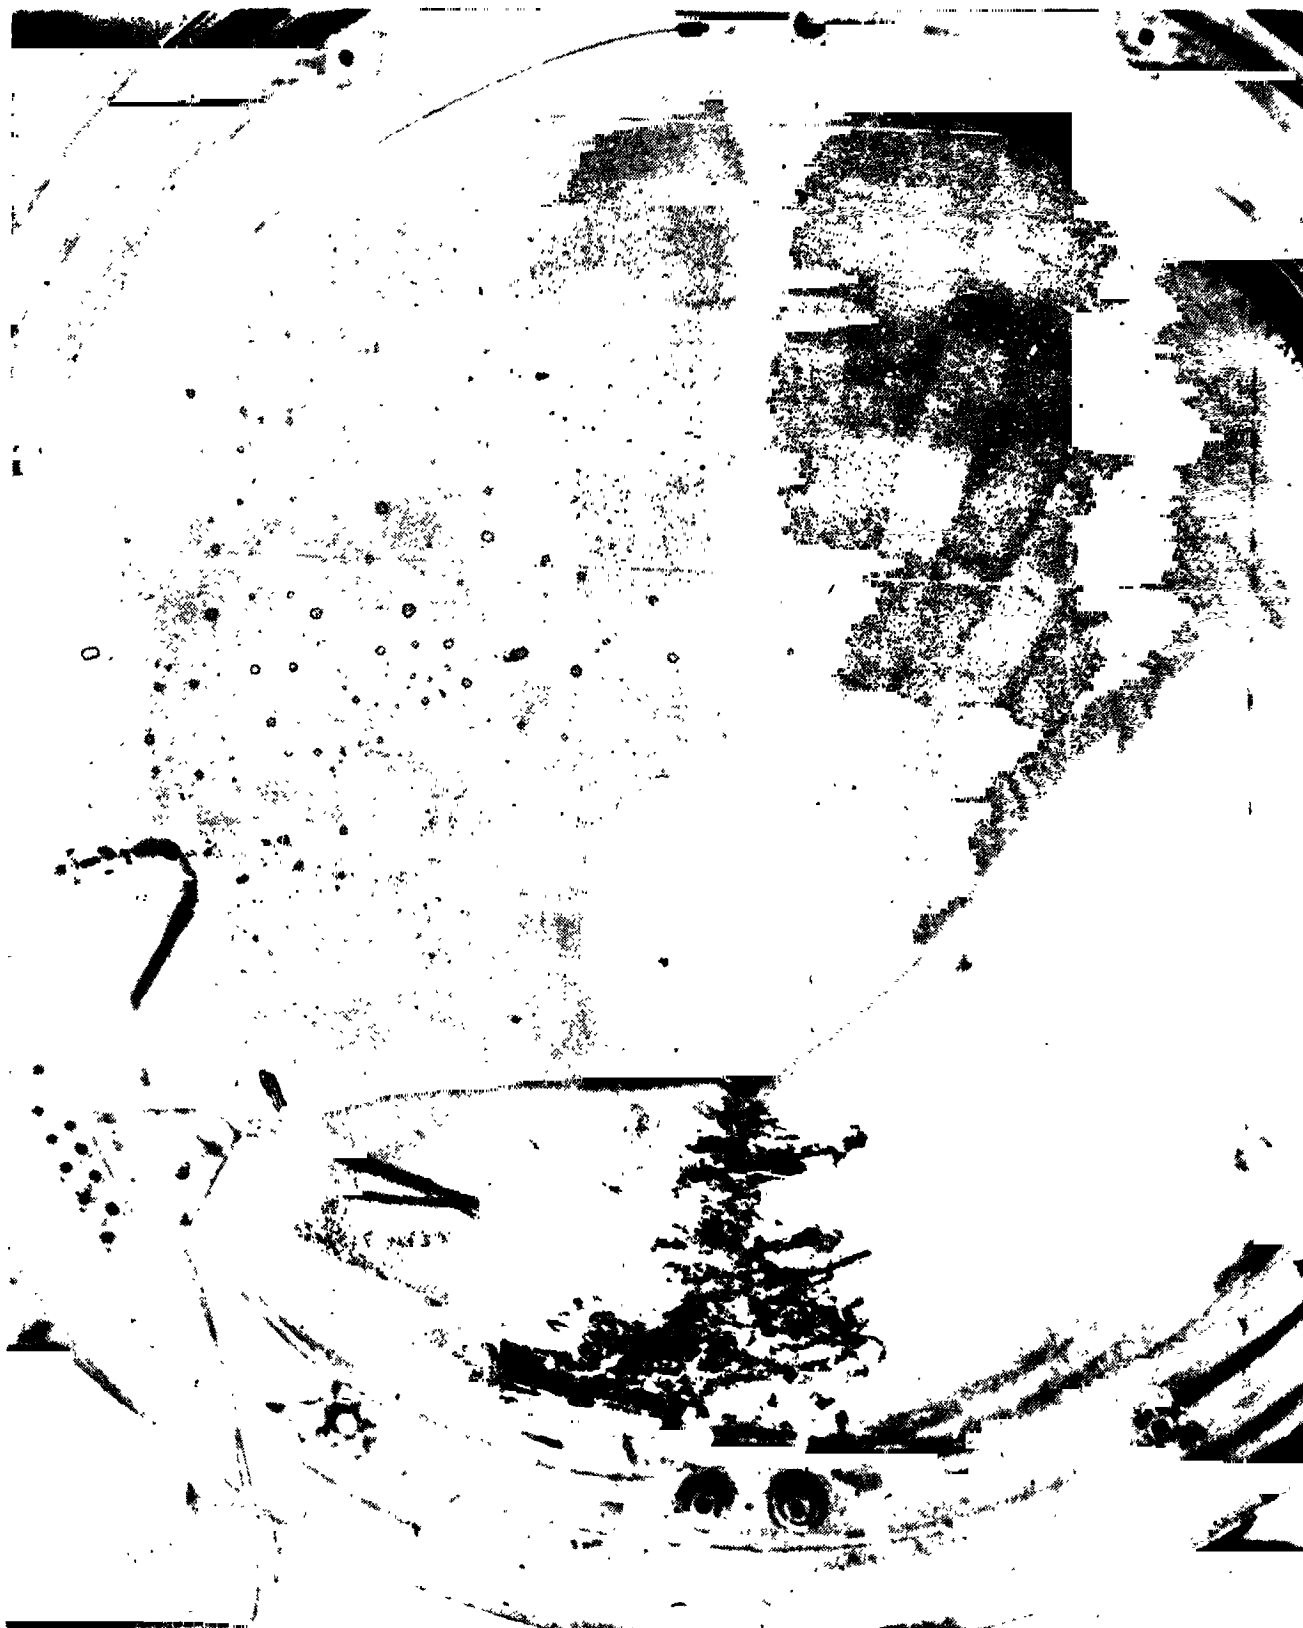
Figure 2 - Remains of AWG No. 8 Ground Wire and Pitot Heater  
Power Harness of Aircraft A after Two Lightning Strikes.

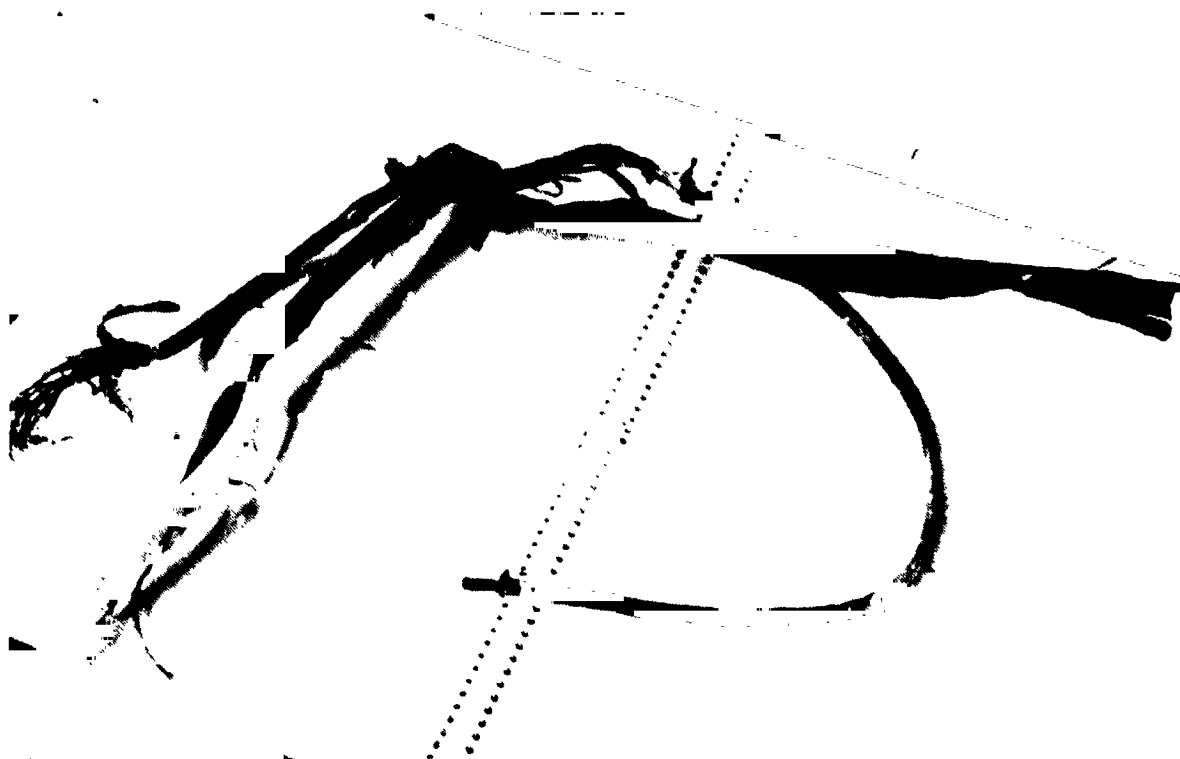
Figure 3 - Remnant of No. 8 AWG Ground Wire (P/N M5086/2-8-9) in Radome of Aircraft A.

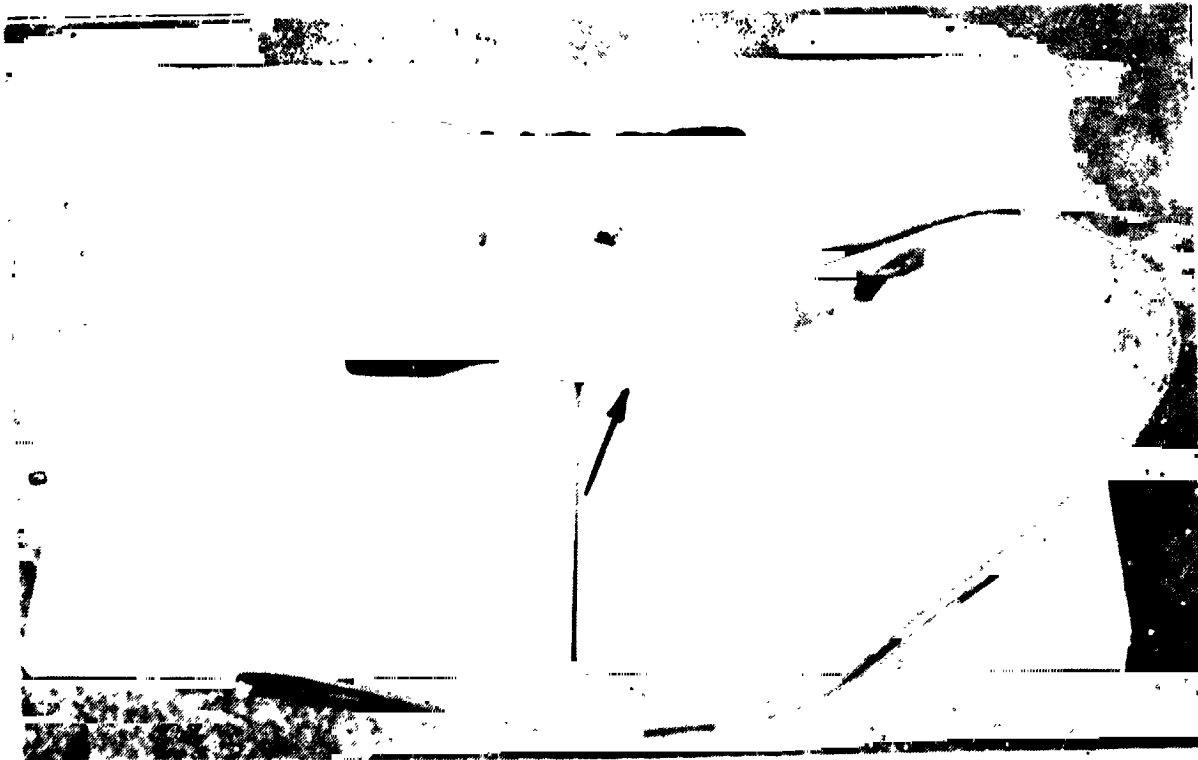
Figure 6 - Evidence of Minor Electrical Arcing between L1 and L2 Windings and the Metal Frame after Potting Material Broke Away (Aircraft A).

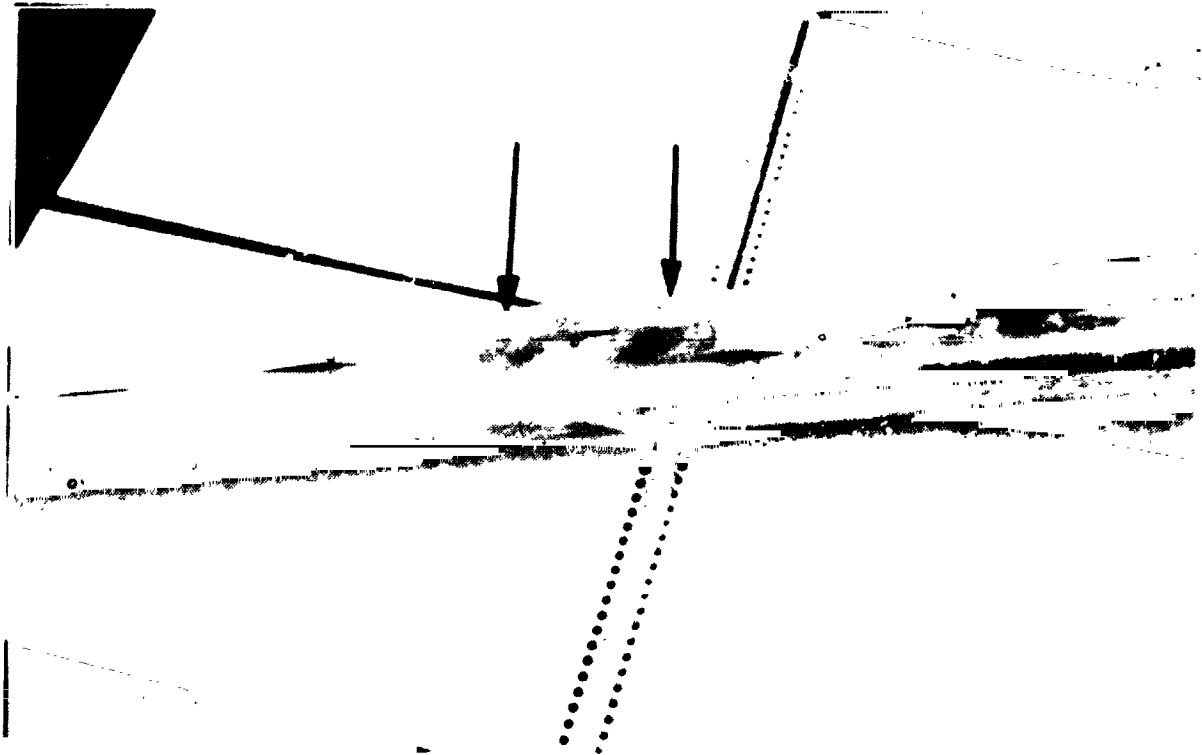
Figure 7 - Dendritic Patterns Left by Lightning Strike Attachment to Pitot Probe of Aircraft B.

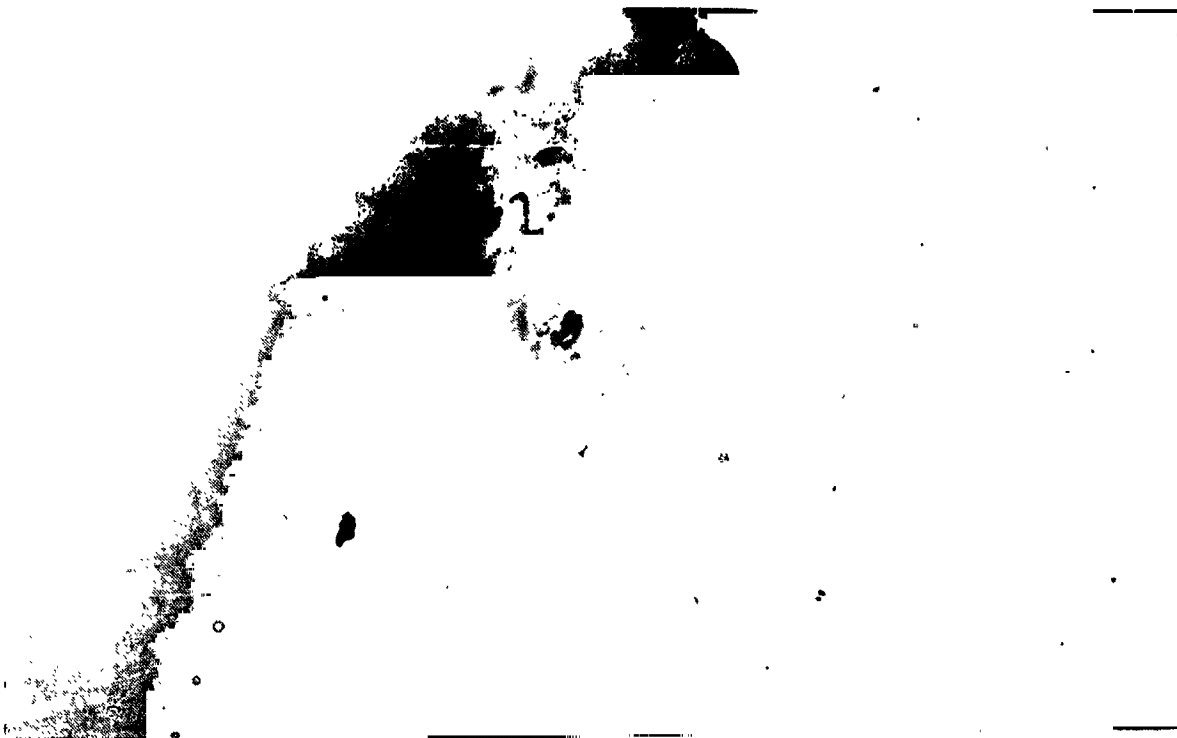
Figure 3 - Inside of Radome of Aircraft B Following Lightning Strike, Showing Copper Deposit on Inside Wall at Forward End.

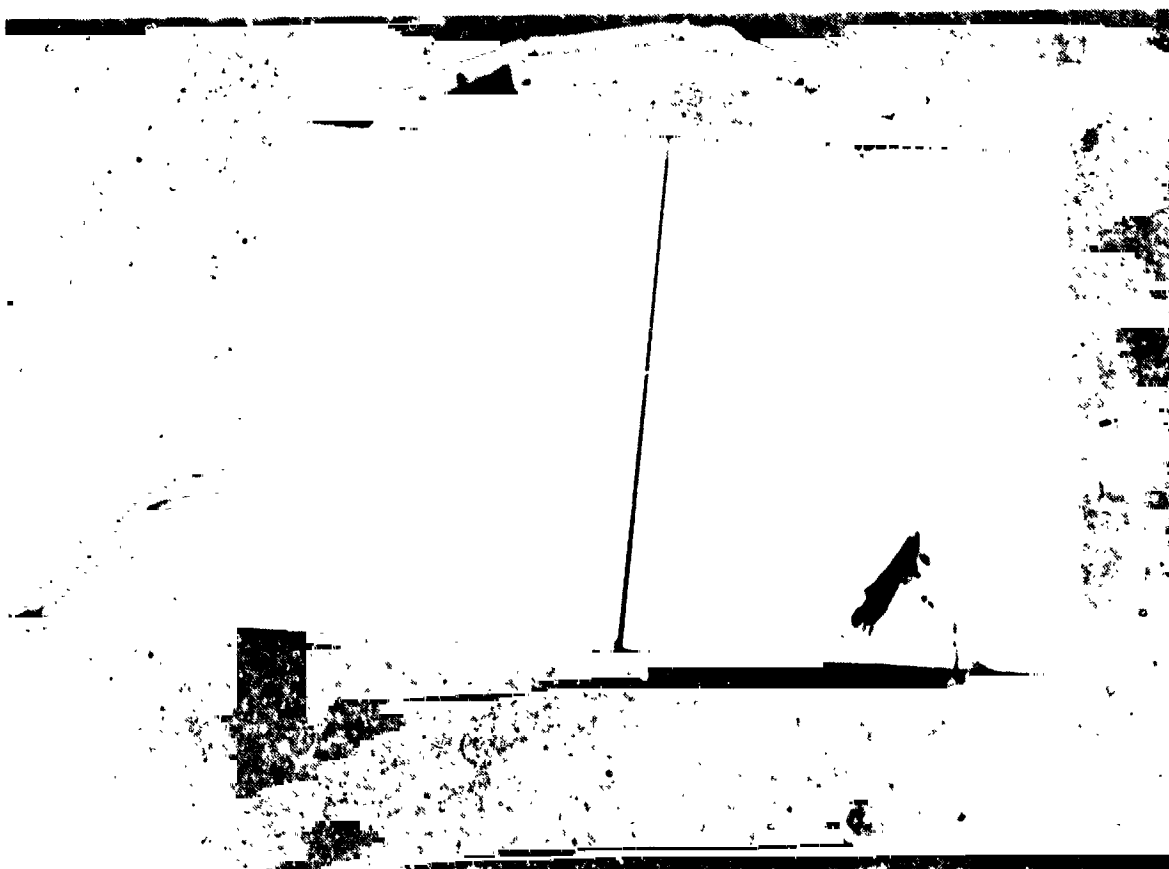
Figure 9 - Remains of Pitot Heater Power Harness after Lightning Strike to Aircraft B.

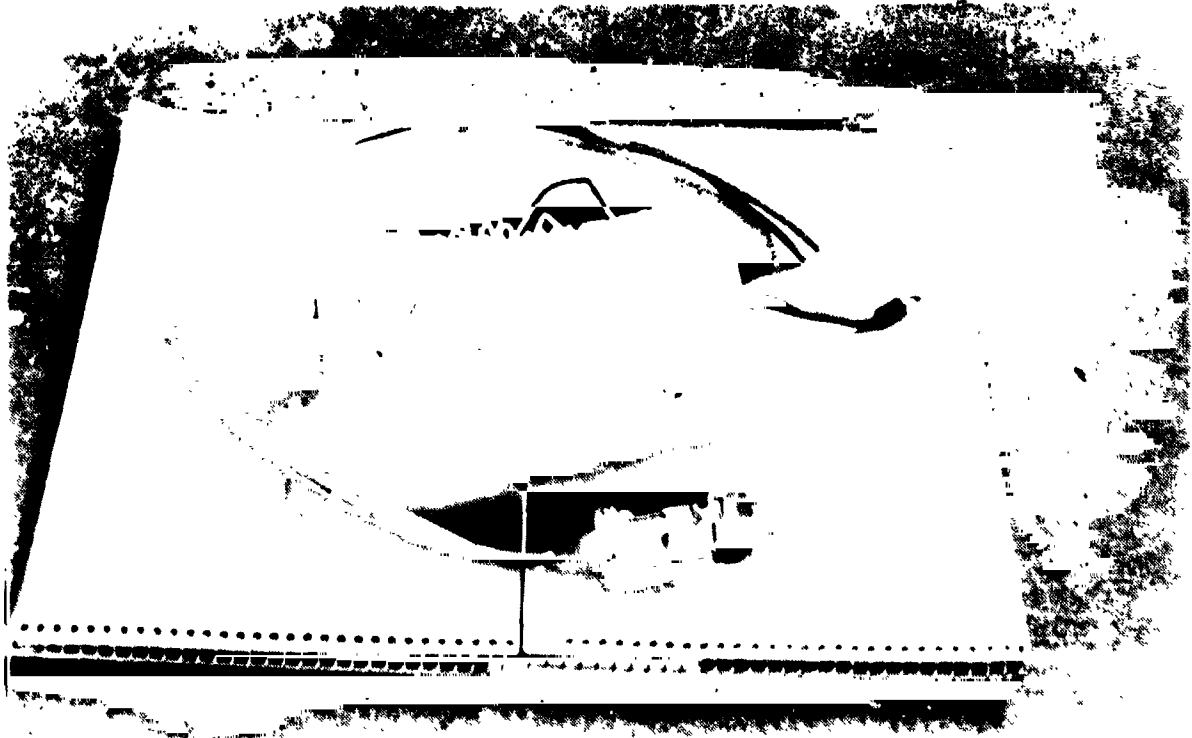
Figure 10 - P/N 3S2060DM185A1 Lightning Suppressor after Lightning Strike to Aircraft B.

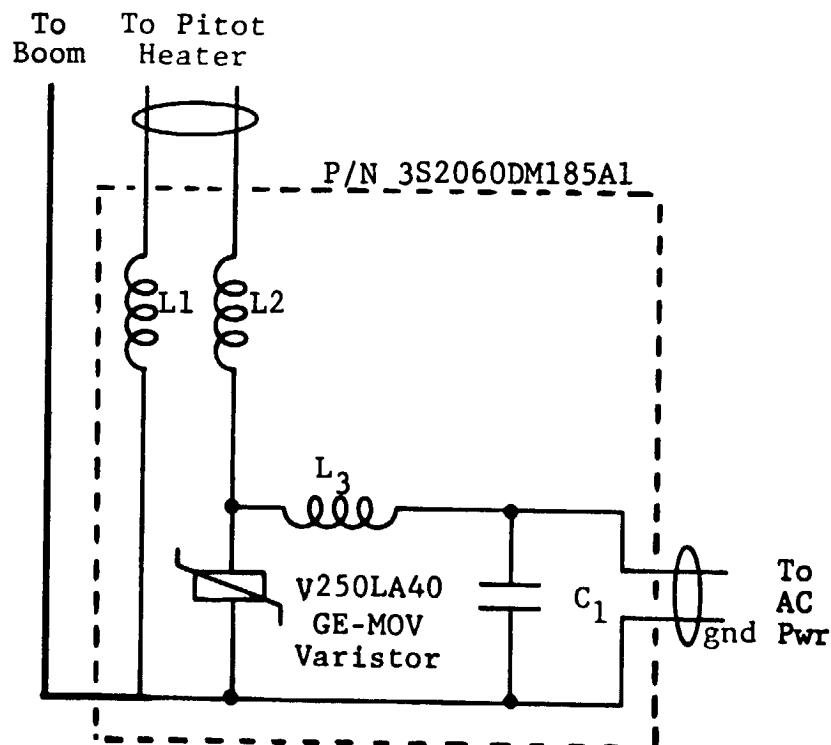
Figure 11 - Basic Electric Circuit of P/N 3S2060DM185A1 Suppressor.
